**MARCHETTI CONSULTING ENGINEERS**  
**25 High Ridge Road**  
**Pound Ridge, NY 10576**  
**(914) 764-9011 Fax 764-9012**  
[info@marchetticonsultingengineers.com](mailto:info@marchetticonsultingengineers.com)

Re: Parking structure at 43 Sylvan Rd, New Fairfield CT

On 7/14/2023 a representative from Marchetti Consulting Engineers (MCE) performed a cursory review of parking structure foundation at the above mentioned address. The purpose of this review was to determine the structural stability and overall construction of the foundation for the parking area. What follows is a description of the structure, observed conditions, and recommendations for the foundation so that the structure can be completed.

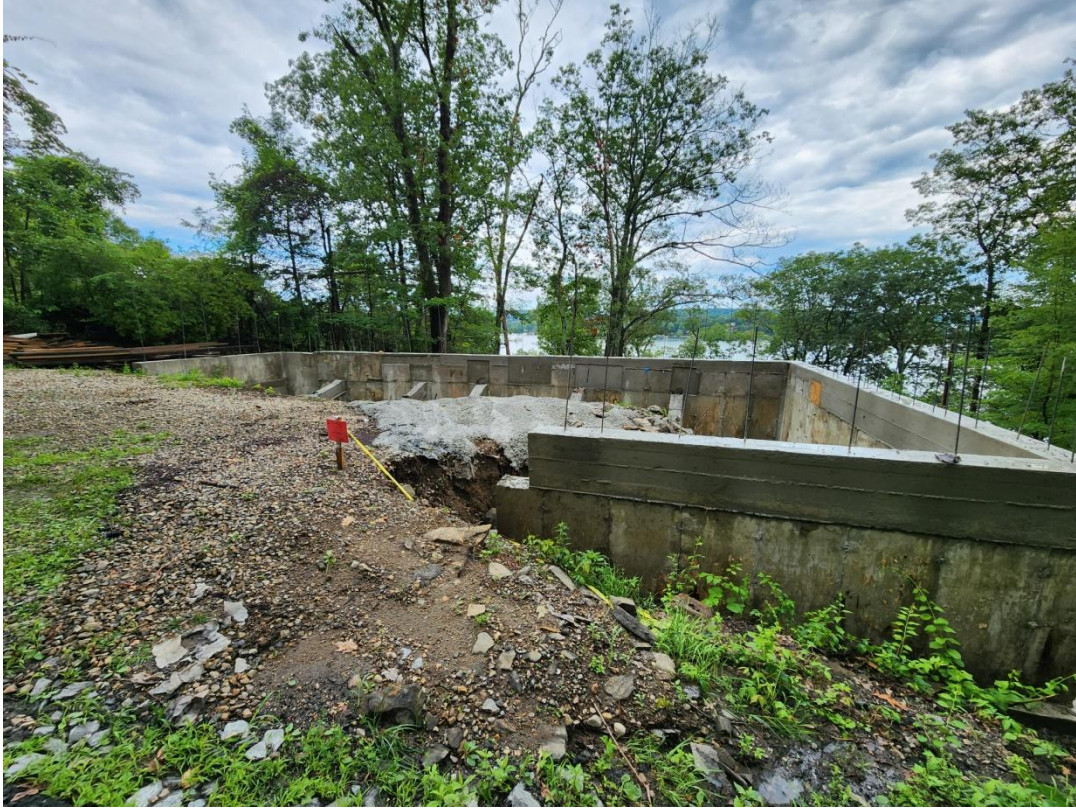
The parking structure is located on the south-west location of the lot; the lot slopes very steeply from the south-west to the north-east, meaning the parking structure top of foundation wall is at grade on the south-west and is a retaining wall on the north-east. The parking structure is approximately 30' by 20' wide by 10' at the tallest. The intention of this parking structure is to park vehicles and allow for a flat space for activities. See Photograph1 for an overall view of the structure:

Photograph 1: Overall view of parking structure.

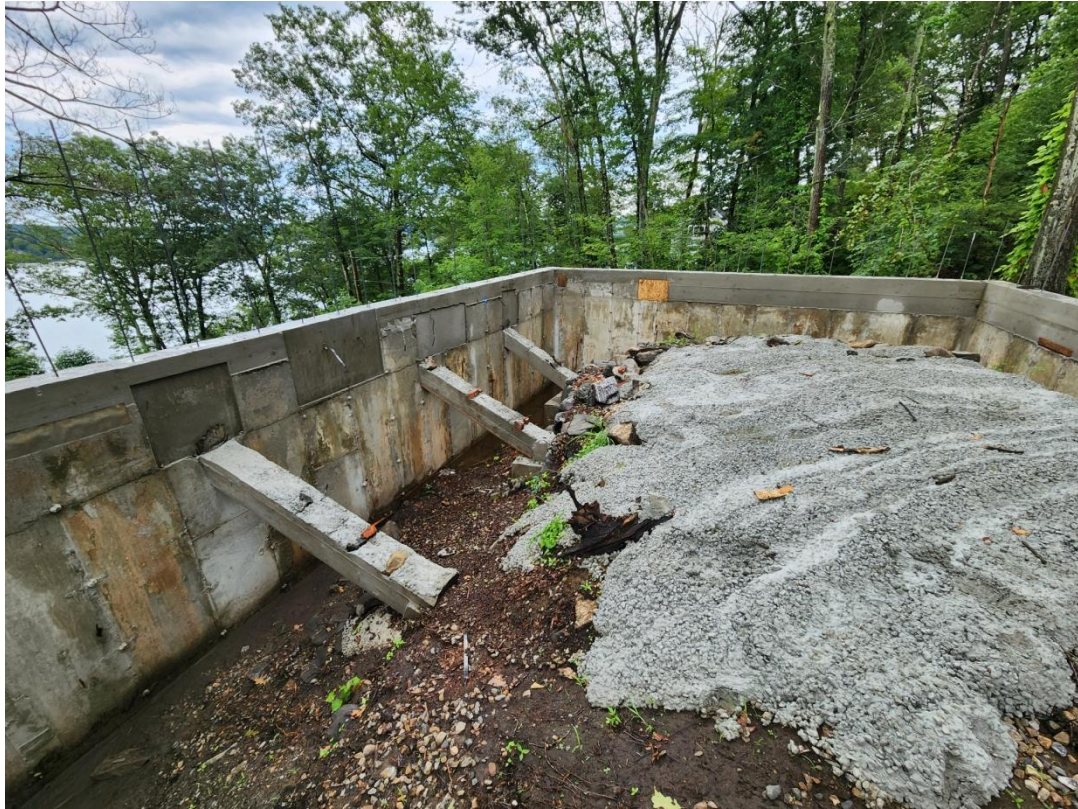
At the time of the review the foundation walls were cast but no backfill was installed so the interior of the foundation wall could be observed. The walls are reinforced concrete, approximately 12" thick. Along the north-east wall, there are five (5) 12"x12" counterforts/buttresses to support the exposed wall height of 10' (Photograph 2). These buttresses are anchored into the bedrock with 24"x24"x24" reinforced concrete blocks. The system is in place to brace the free standing wall from lateral forces due to surcharge as well as the retained soil fill.

Photograph 2: Overall view of counter forts/butresses.

Based on the observed conditions, the existing construction appears to be to code: The braced wall condition presented by the counter forts/butresses stabilizes the wall from any lateral pressure exerted on it. The reinforcement appears to be #5's @ 12" o.c. which is appropriate for the unbraced height of the wall and an assumed 4,000 psi foundation. Although the wall reinforcement could not be determined, and ACI318 requires any wall which is 12" thick to be double matt reinforced, IBC Table 1807.1.6.2 Concrete Foundation Walls recommends that the minimum reinforcement bar size and spacing for a 12" thick wall, with 10' maximum unbalanced backfill height be #6's @ 38" o.c. which is the equivalent of #3's @ 12" o.c..

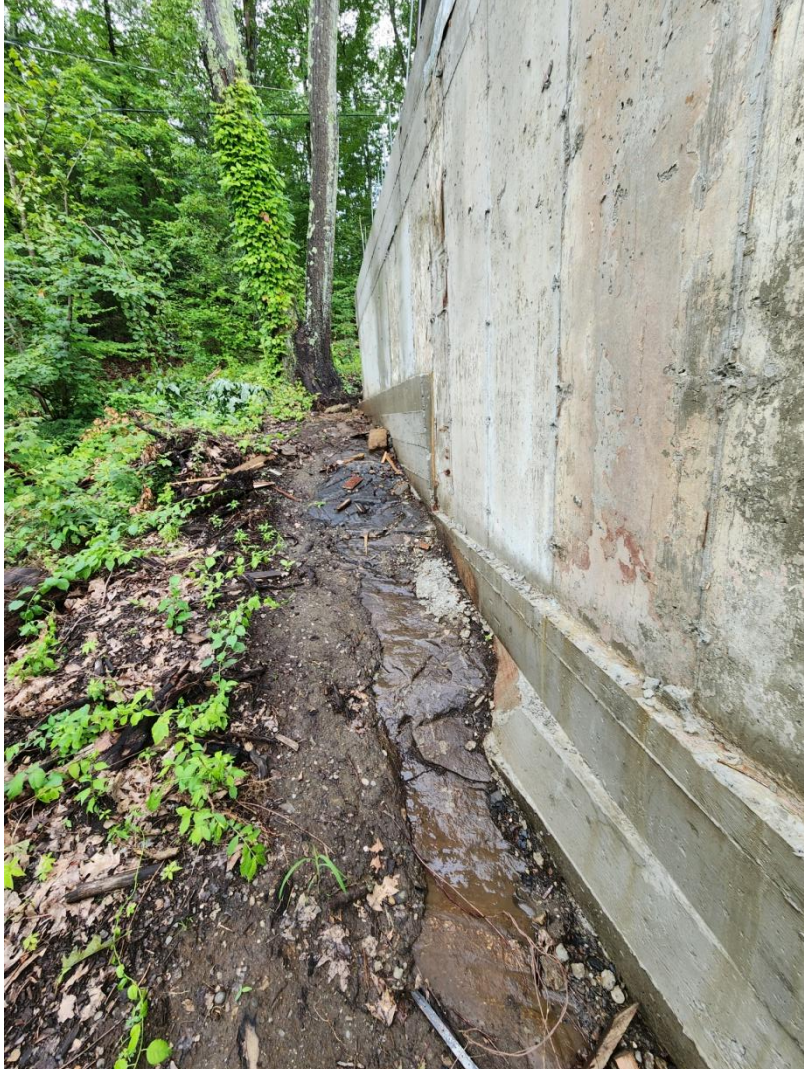
The walls themselves have what appear to be #5 verticals @ 12" o.c. extending from the top of the wall. Although the construction was not observed, it is assumed that the reinforcement continues through the wall. The majority of the surrounding area is exposed crystalline bedrock; therefore the foundation is assumed pinned into the bedrock (Photograph 3).

Photograph 3: Bedrock observed at stem wall casting.

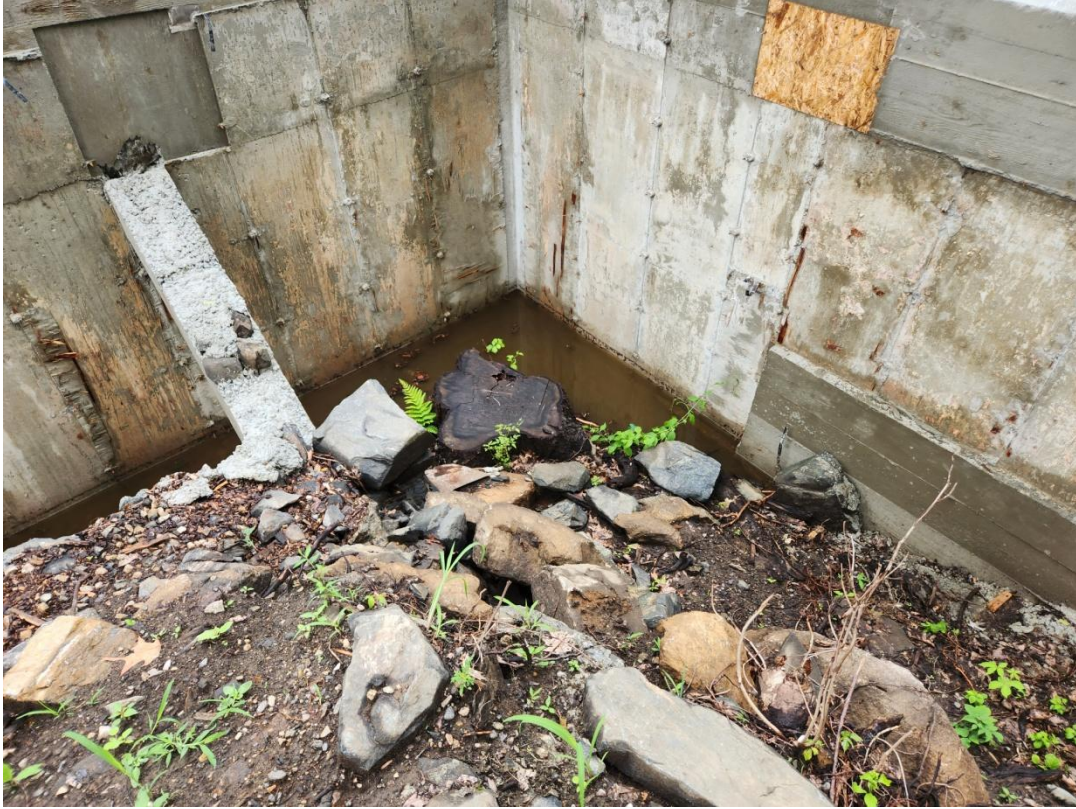
It was observed that there are some tree trunk and roots still present in the excavation (Photograph 4)

Photograph 4: Observed tree trunk/roots in excavation.

1. It is recommended that the existing tree trunk and roots be removed prior to any backfilling operation; when the tree eventually deteriorates and rots, then the backfill located on top of the tree will shift causing subsidence of the soil strata.
2. No behind the foundation wall drainage was noted, so it is recommended that a curtain drain be installed and pitched to the north-east corner of the foundation walls. From there, the drainage line can penetrate the foundation and then pitch to an engineered storm water retention system.
3. Clean, run of bank fill, having little to no clays should be installed as backfill and compacted in lifts to ensure that no voiding occurs and that all of the soils are uniform. A
