## **BOARD OF FINANCE**

### **BOF Capital Improvement Plan Subcommittee agenda**

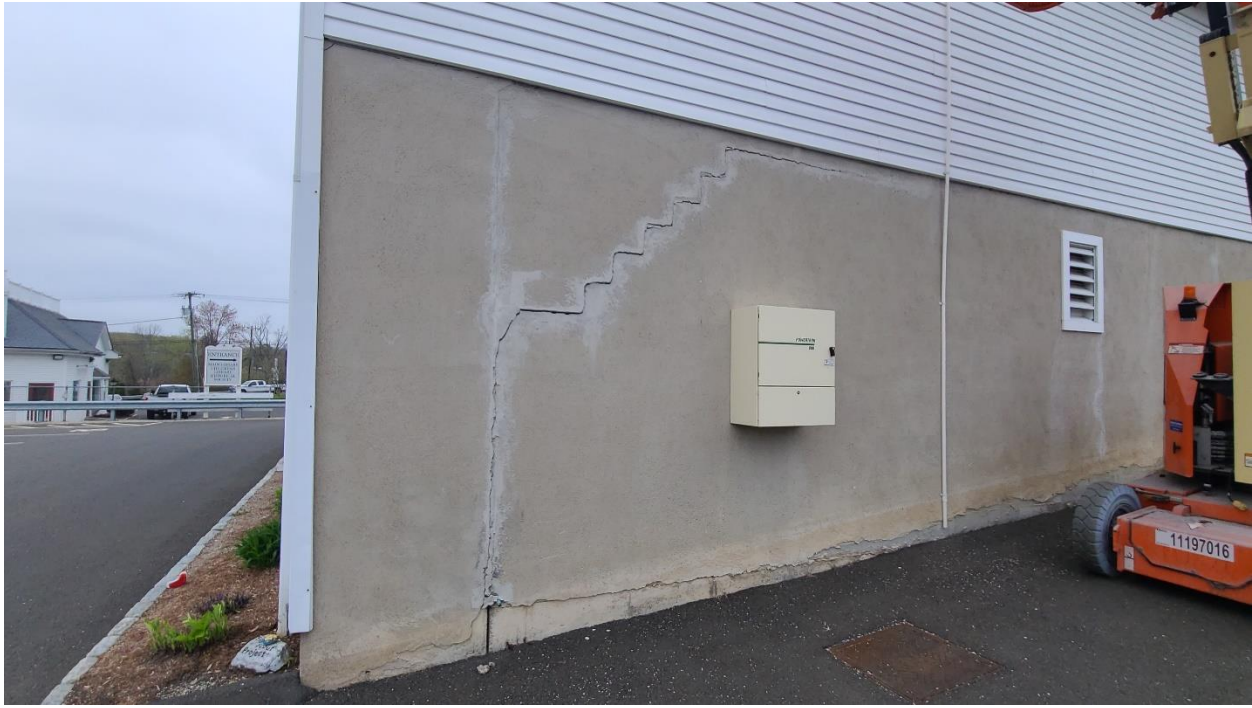
*Photograph 1: Foundation crack - west wall*

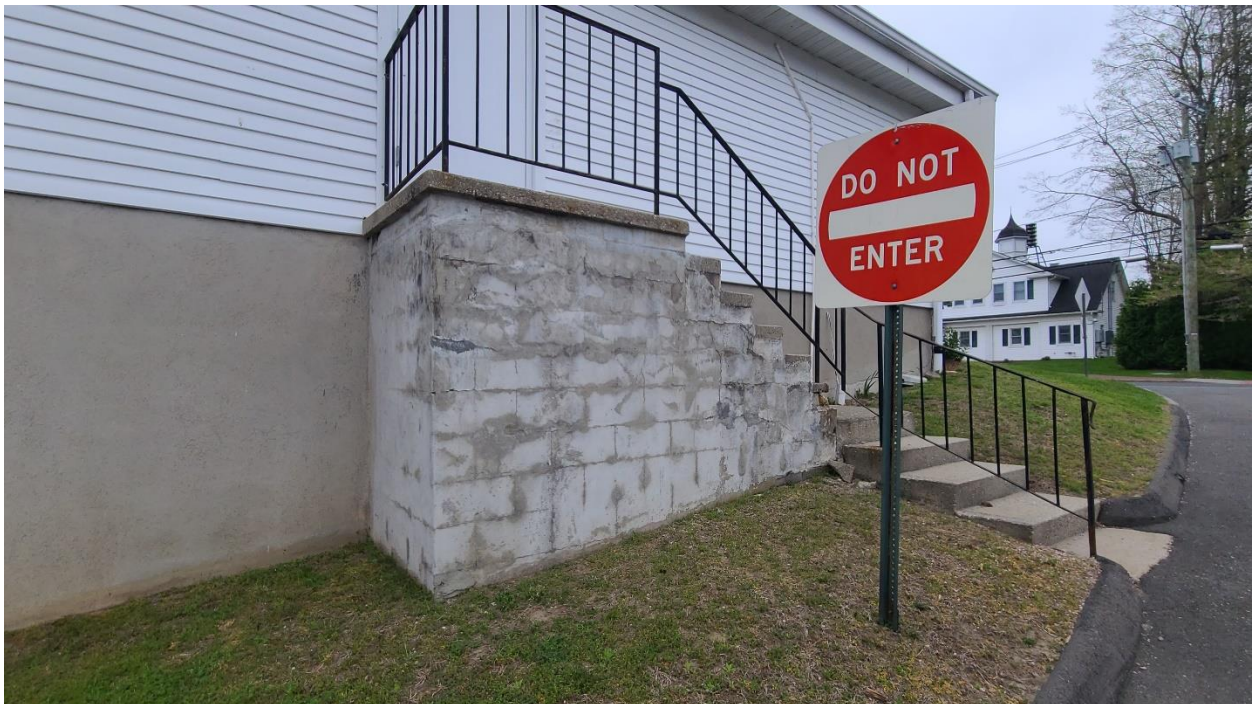
*Photograph 2: Emergency egress landing and stairs*

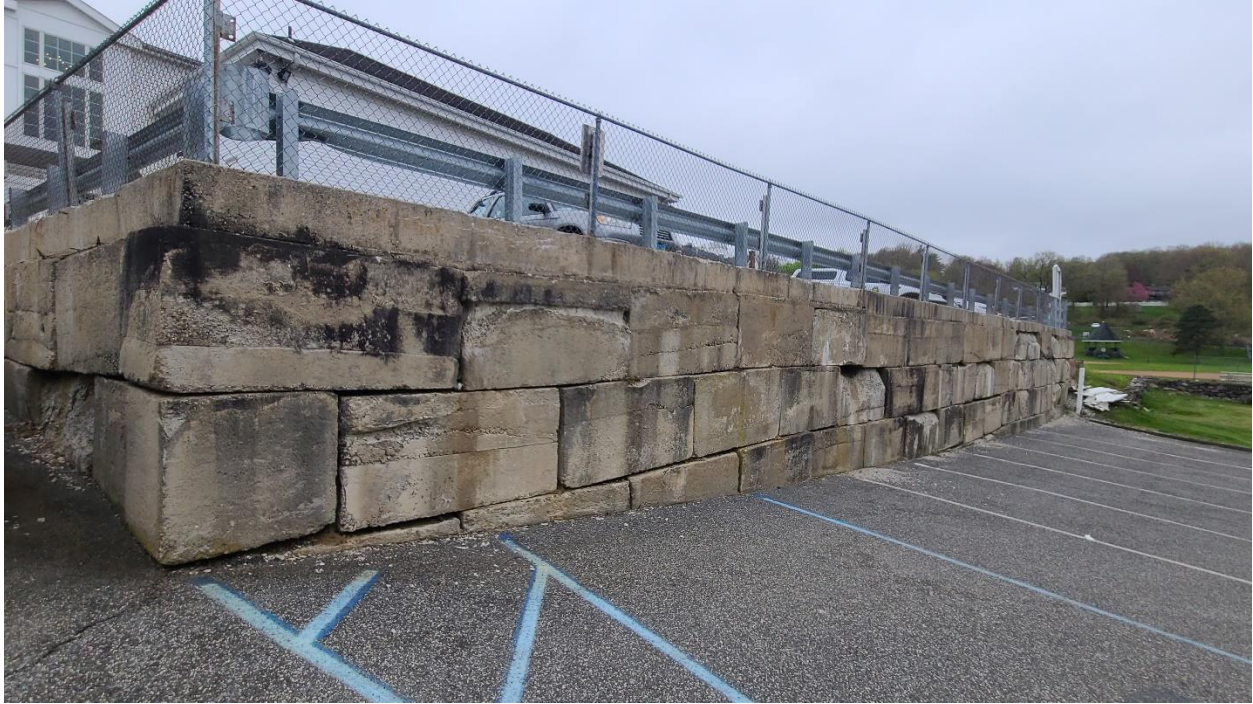
*Photograph 3: Parking lot retaining wall*

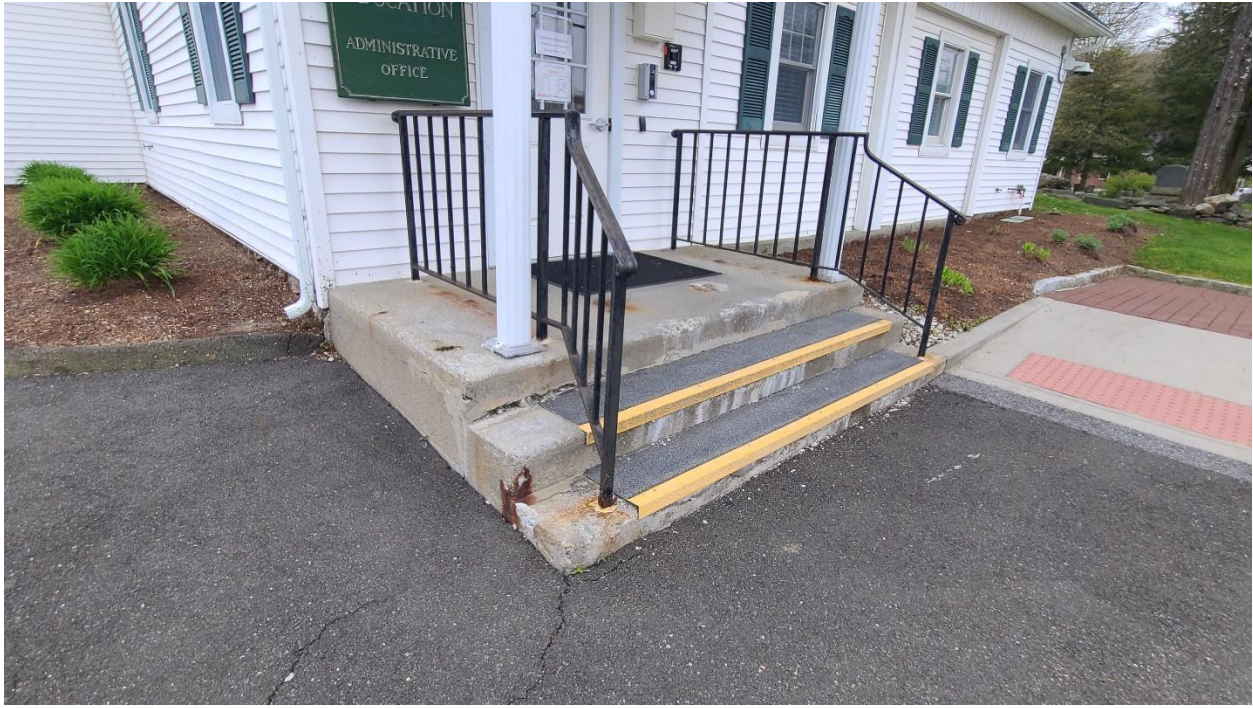
*Photograph 1: Deterioration at front steps*

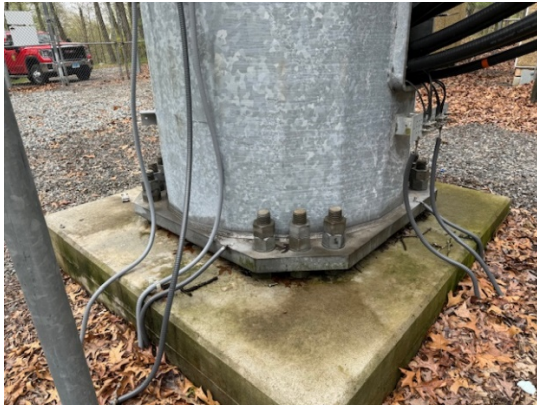
Condition Assessment 5-1-24

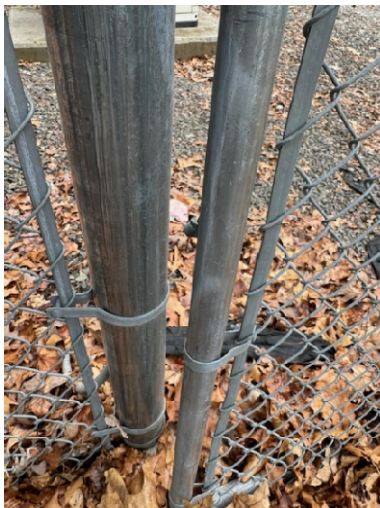
Broken bottom hinge of gate

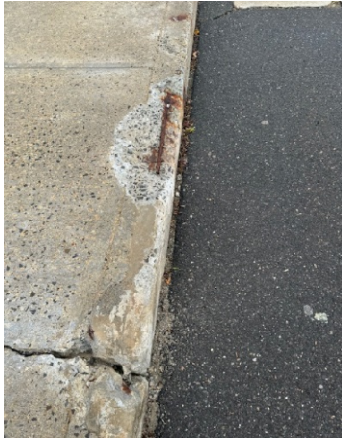
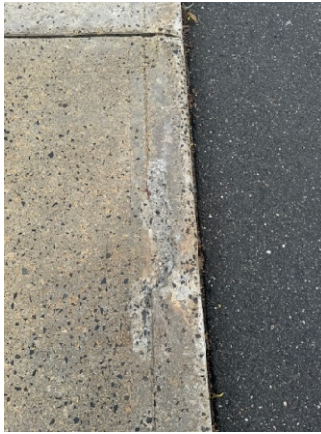
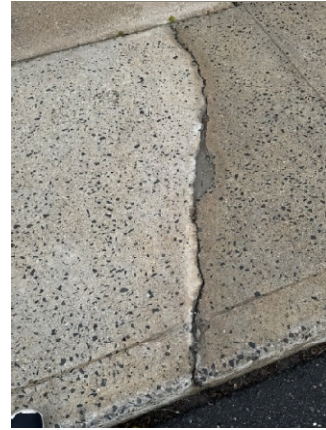
3 Areas of Main Entrance sidewalk repair required

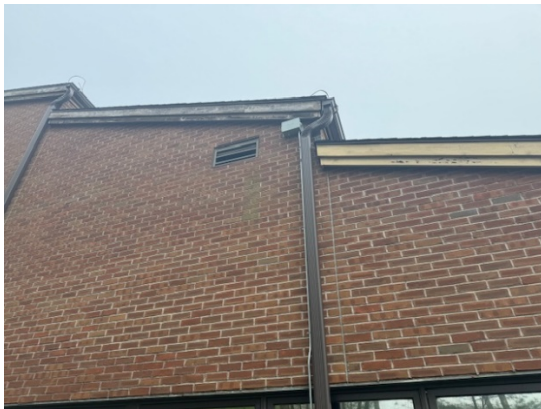
Fascia board rotted and in need of repair

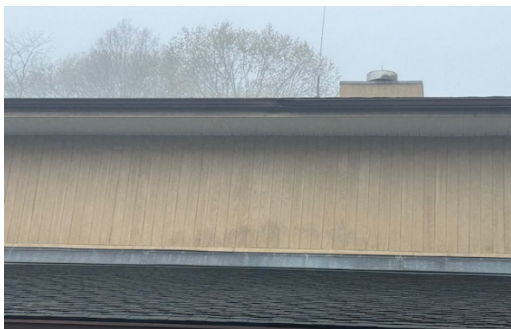
Gutter in 2 places- dented but functional

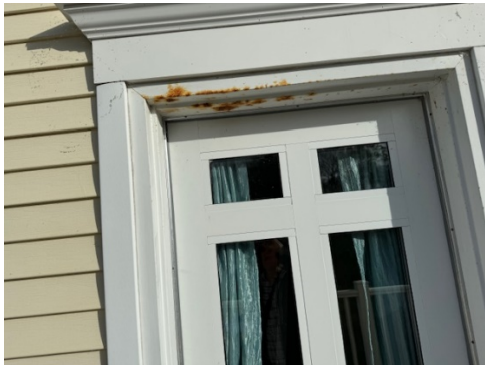
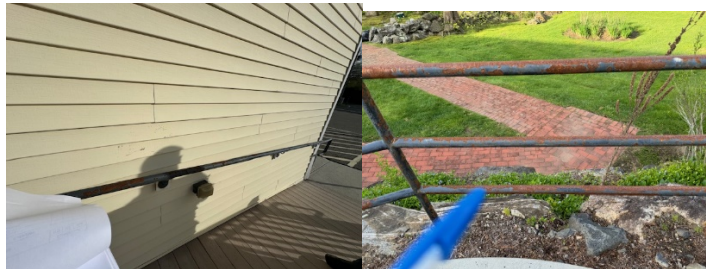
Header in need of painting

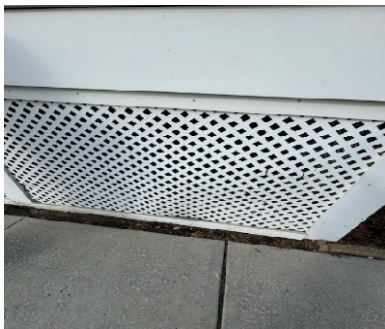
Broken & warped lattice

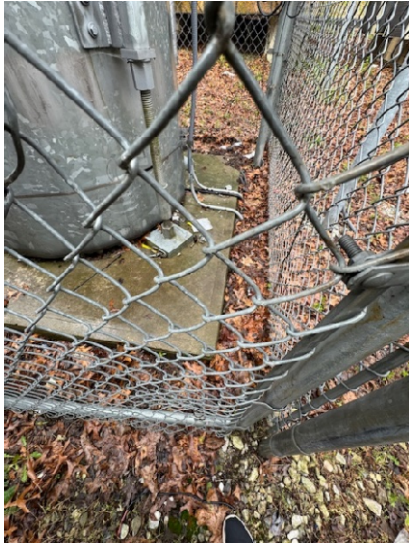
Condition Assessment photos 5-1-24

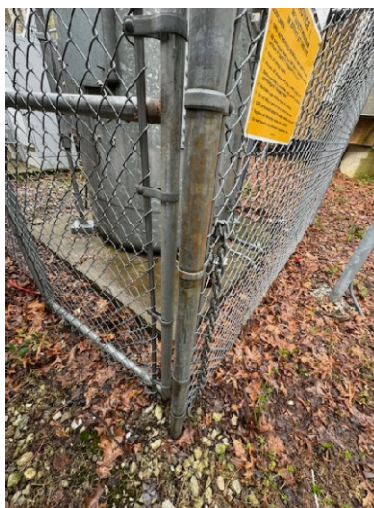
Gate at Tower not secured

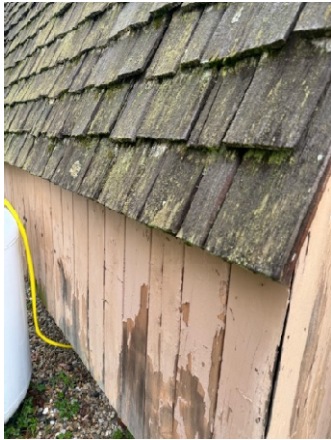
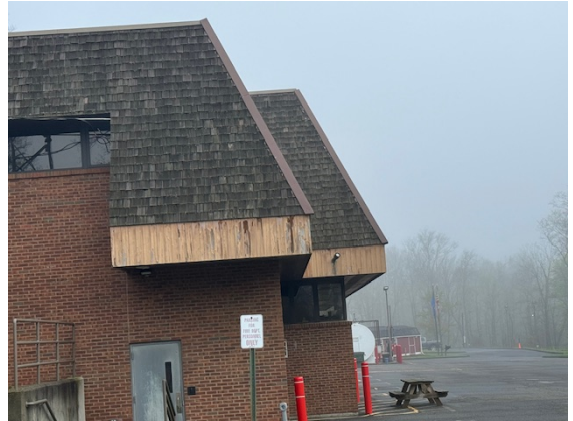
Damaged & rotting wood shingles & fascia board

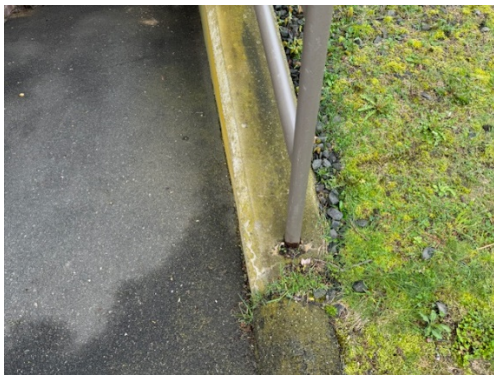
One metal handrail rotted at concrete embedment location

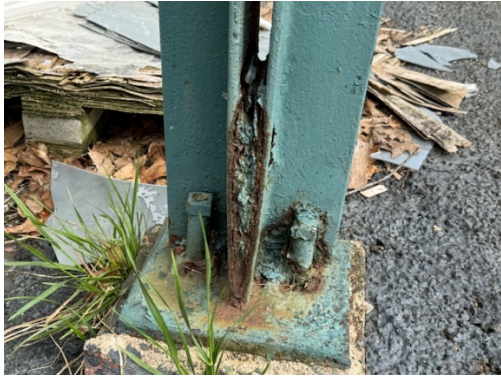
Corroded Column Base

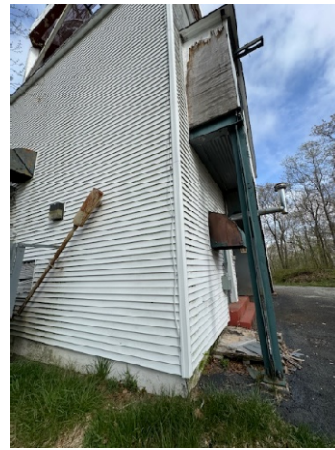
Column supporting exterior stair landing

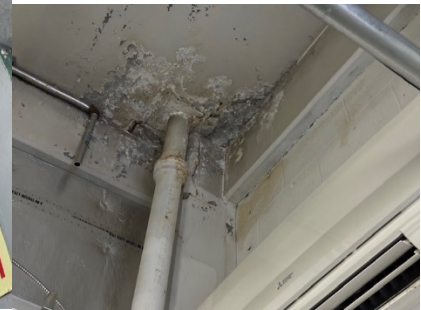
Water thru damaged concrete

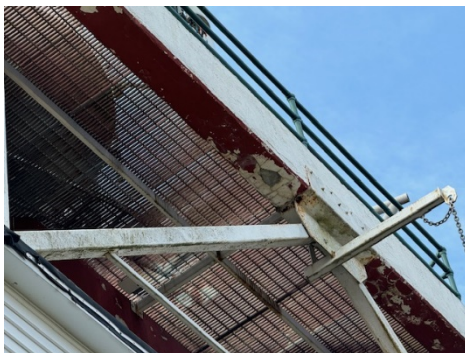
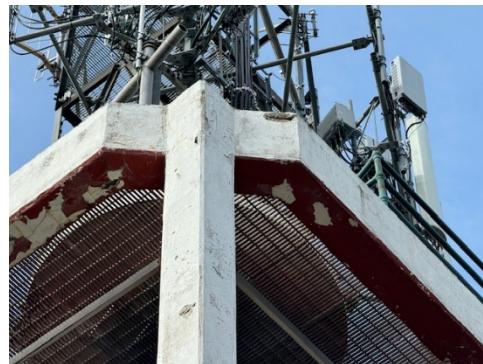
Rusted rebar and spalled concrete at top beams

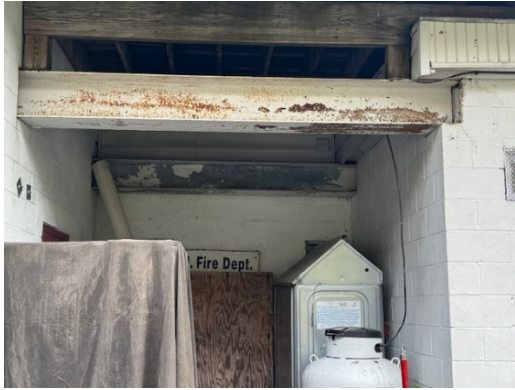
Two steel exterior beams in need of paint

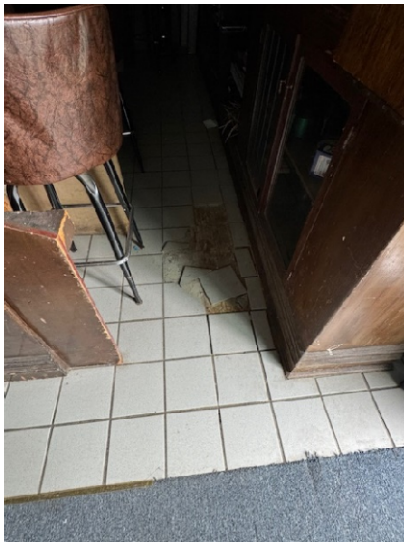
Holes in ceiling by Elevator contractor

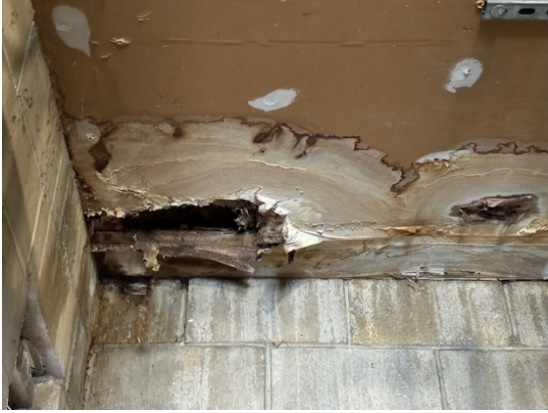
Water damage in ceiling of Mechanical room

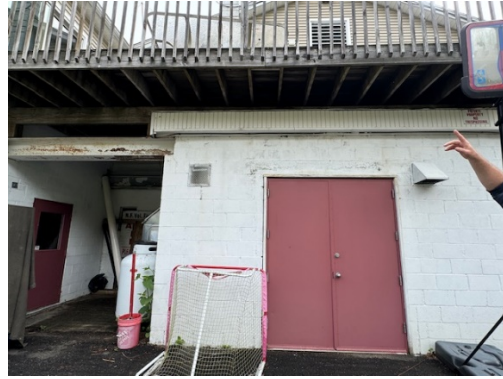
View of mechanical room with wood deck over leaking flat roof

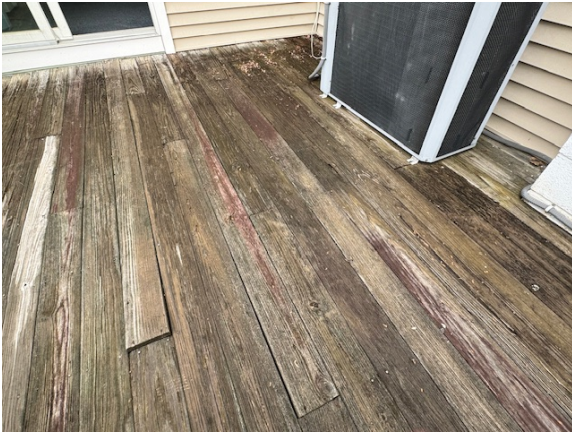
Warped & Rotting wood deck with equip set on it

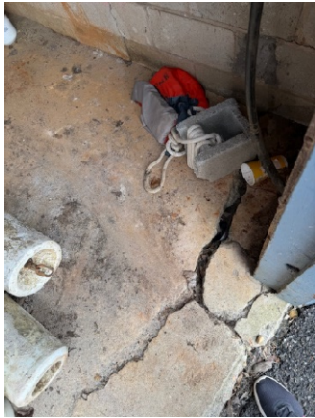
Basement slab cracked & settled

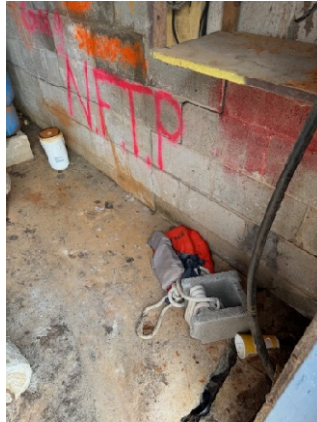
Cracks in Foundation walls

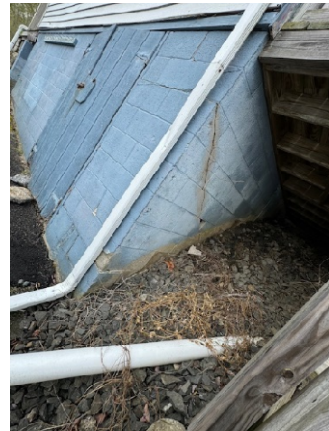
Exterior door damage

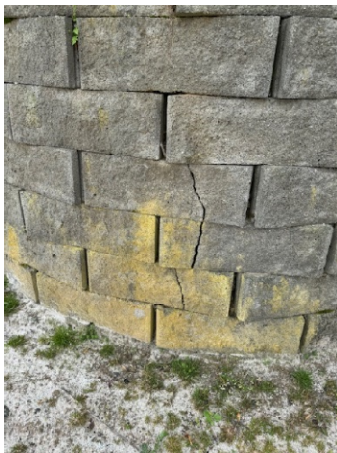
Crack in fnd wall under deck

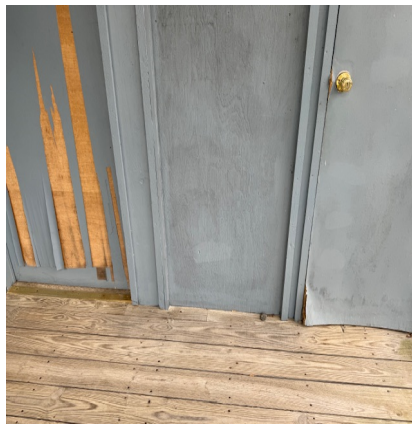
Interior door damage

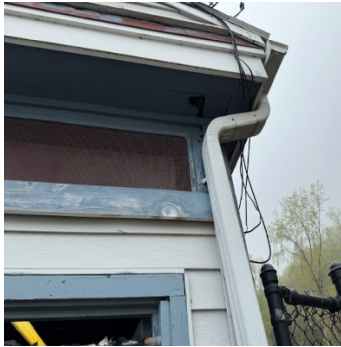
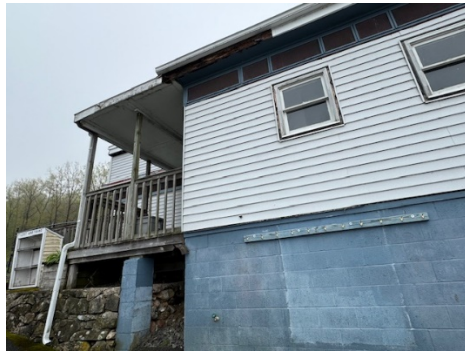
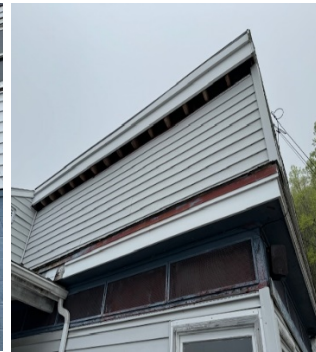
Soffit & eave framing deterioration

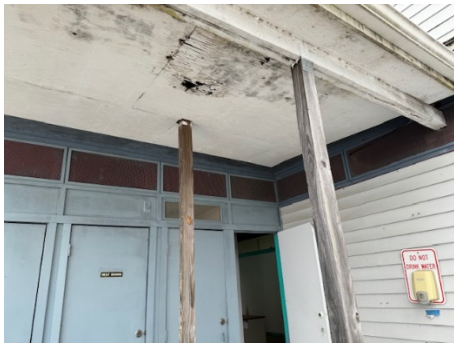
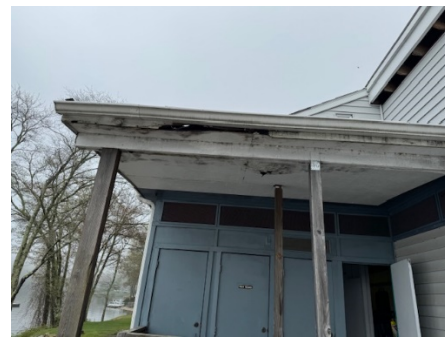
Wood ceiling over deck rotten

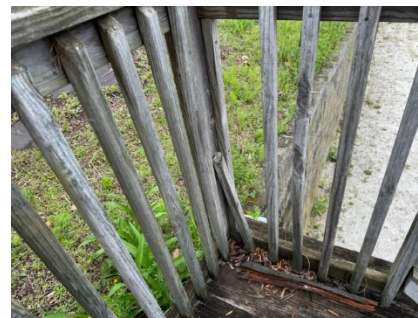
Column cap plate with no column in basement

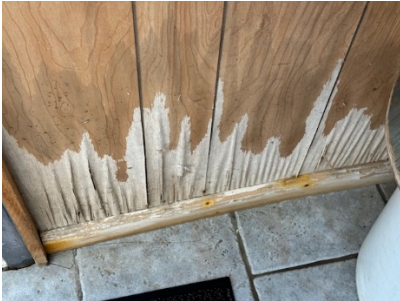
Interior wall damaged

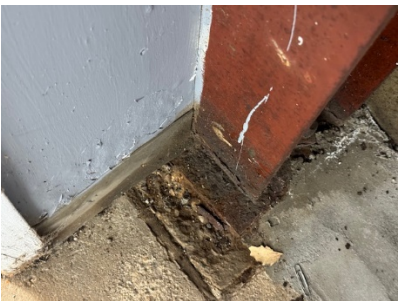
Interior column base rusting

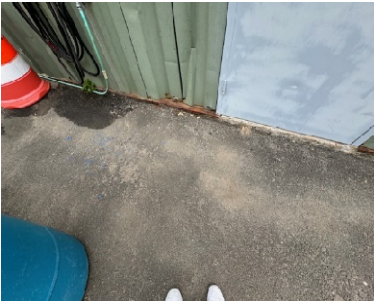
Exterior wall & sill plate rusted

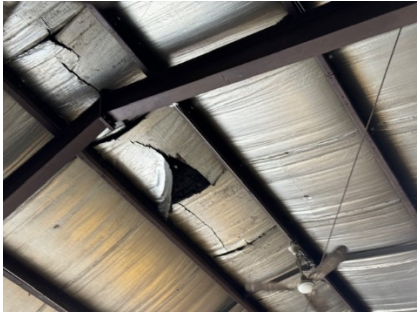
Damaged ceiling insulation

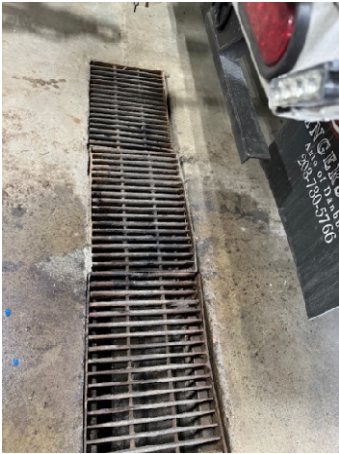
Floor grates not seated properly

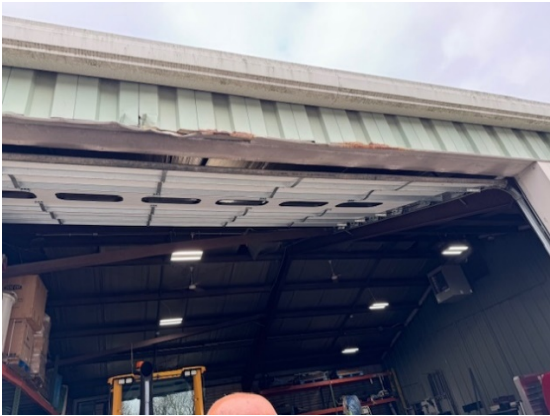
Overhead door header rusted

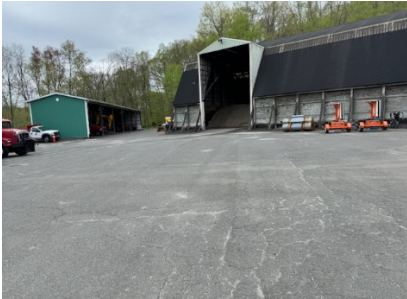
Storage & Sand Buildings

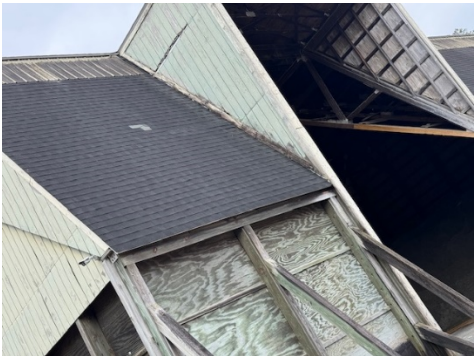
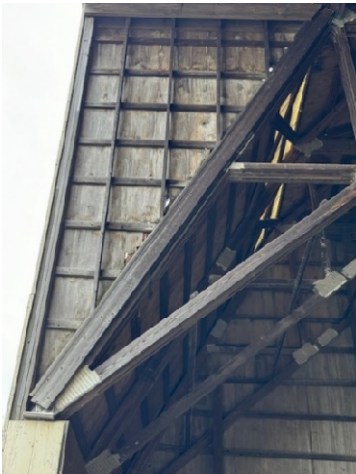
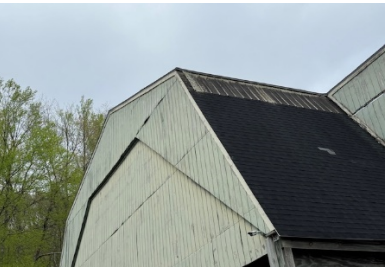
Sand building with deteriorated siding, roof tiles missing and rotten trim board

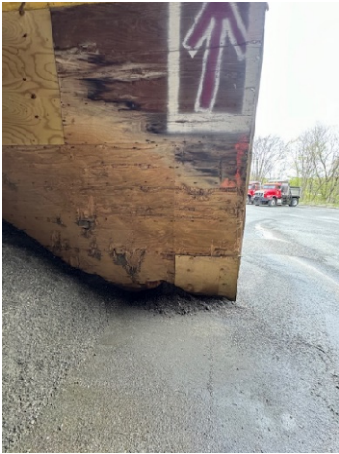
3/4-inch interior wall plywood damaged in few areas

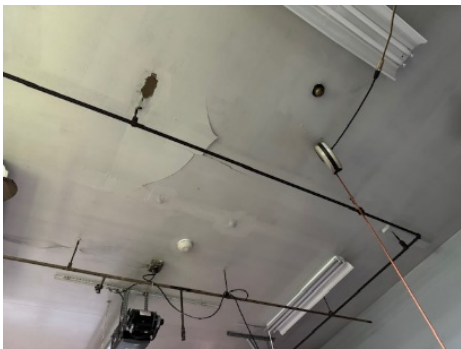
Notes: Ceiling crack to be monitored
